# Manhole Inspection Summary

Manhole # S15MM1022MH

**Location** Address: **4547 FINNEY AVE**

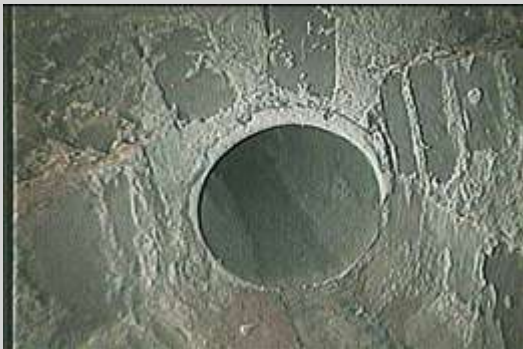
### 6 in. Circular Gravity Sewer Pipe In @ 3 O'Clock

Pipe Material: **Clay** ☐ Pipe Lined

Invert Depth: **9.45** (ft.) Flow Characteristics: **Slow**

Infiltration: **None** Pipe Seal Cond: **Unknown**

Connects To: **House connection / Service line**

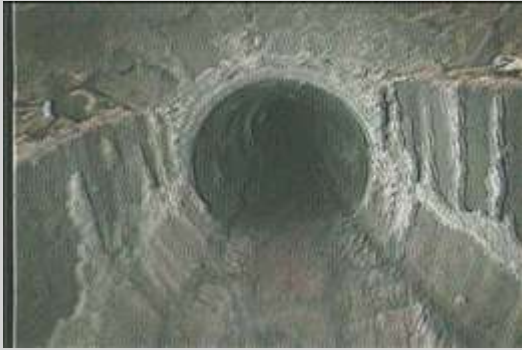
8 in. Circular Gravity Sewer

Pipe Material: **Clay**

Infiltration: **None**
